# **Thermal imaging of the outer surface of the Laboratory for engines and vehicles at the Faculty of mechanical engineering and naval architecture**

## **ABSTRACT**

Laboratory for engines and vehicles at the Faculty of mechanical engineering and naval architecture has been recently renovated by installing thermal insulation on the outer surface of the three facades of the building: south, east and north facade.

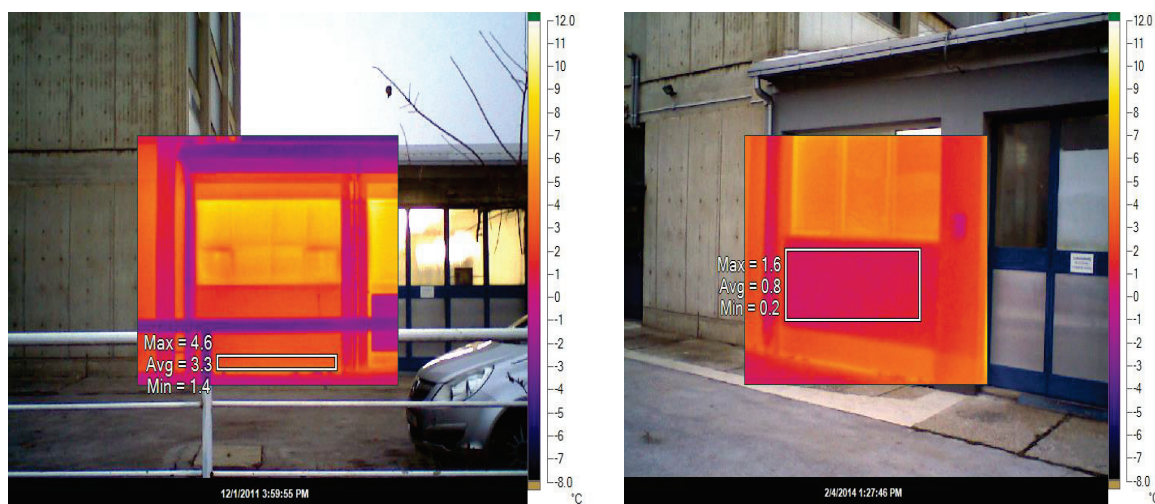
Fig. 5. South façade thermal imaging comparison

Comparing these two thermal images one can see stark contrast between facade surface temperatures. Before placing the thermal insulation, average surface temperature was 3, 3 °C, whereas after performed works 0, 8 °C representing vast heat losses reduction.

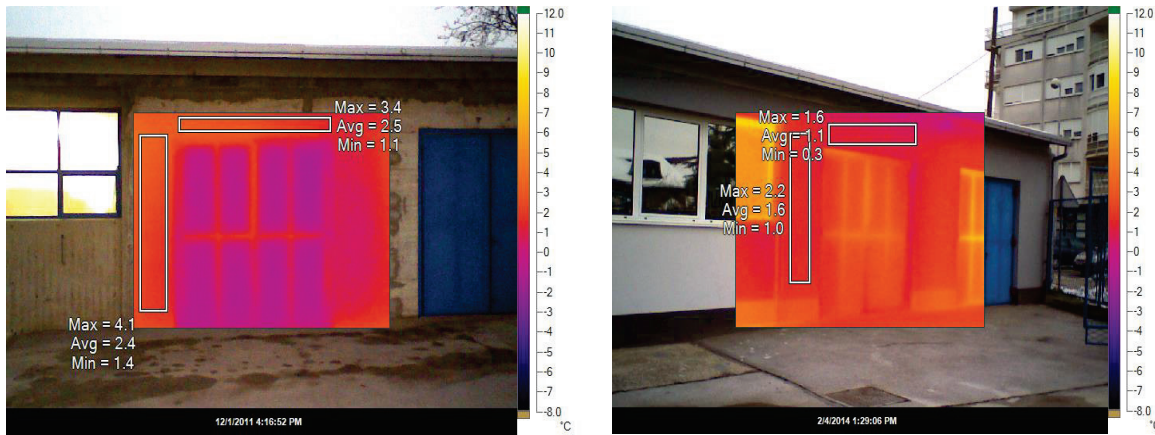
Fig. 6. South façade thermal imaging comparison

Apart from difference between surface temperatures of selected areas, one can see that placed thermal insulation provides equally good results at the bearing walls and as well as above the doors.

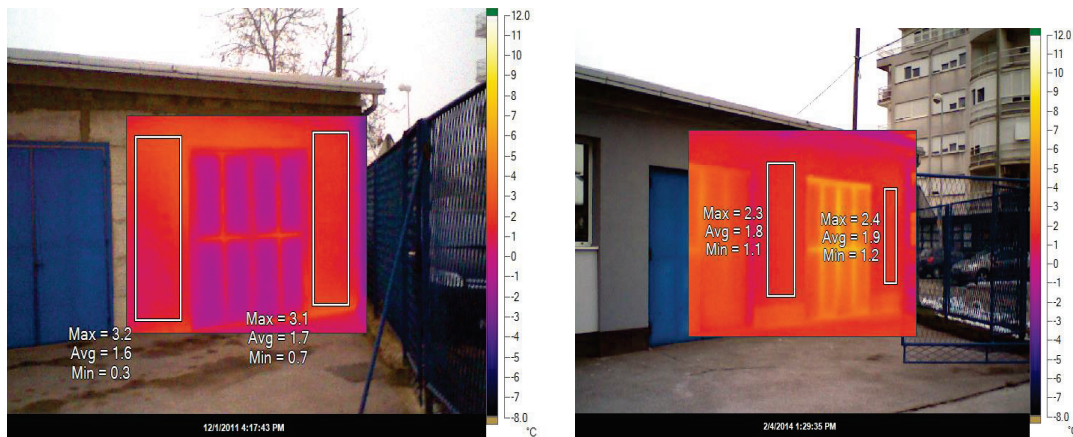
Fig. 7. South façade thermal imaging comparison

Fig. 7. shows unexpected situation. It is obvious that the average surface temperature after placing the thermal insulation is higher than before. One of the reasons of such situation is the radiator which generates heat (before placing thermal insulation this room was not used and therefore the radiator did not generate heat). Regardless of whether the place is heated or not, here we can see inefficiency of placing the thermal insulation.

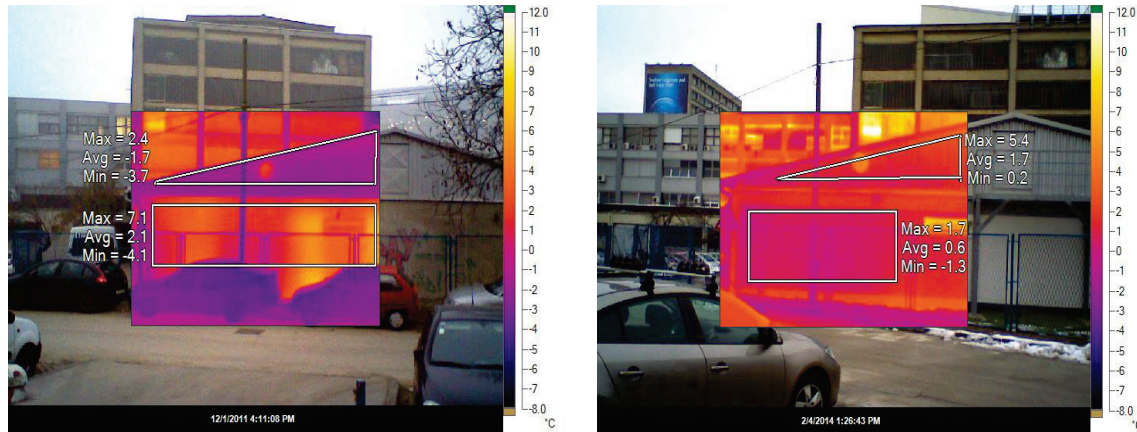
Fig. 8. East façade thermal imaging comparison

First, if we look at lower part of the facade, we can see reduced heat losses, especially if we look average surface temperature which amounted 2, 1 °C before, and 0, 6 °C after placing thermal insulation. Another indication showing improved situation is solving interior heat losses problems caused by radiators.

Now, if we look the upper part, we can observe that the average surface temperature on the left thermal image is 2 °C lower than the one on the right. Reason for this is the fact that before placing thermal insulation loft space was not heated. Ventilation shaft continues to represent thermal loss. During taking thermal images there were some obstacles like: parked cars, trees, fence and these had to be taken into account.

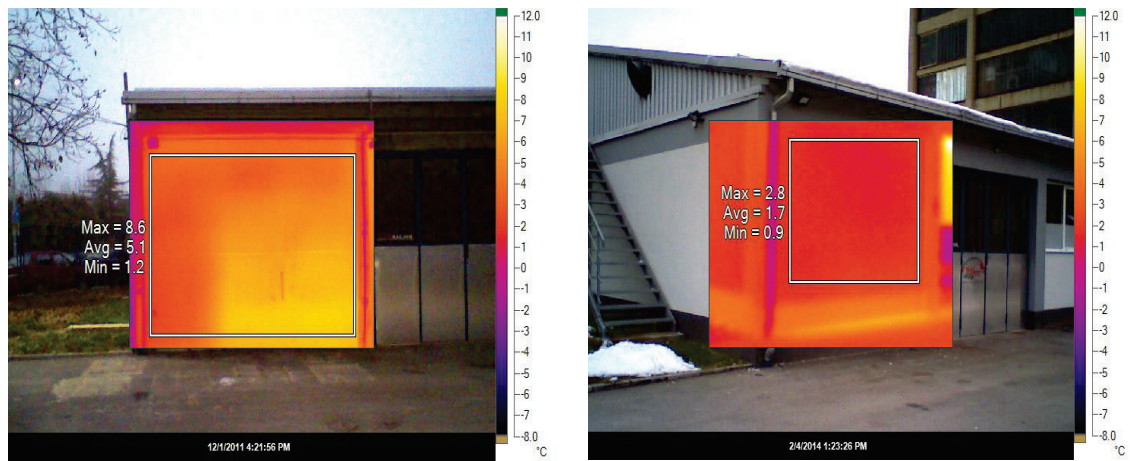
Fig. 9. North façade thermal imaging comparison

North façade best demonstrates the efficiency of placing the thermal insulation of the façade. Thus, figures 9., 10. and 11. show the average temperature difference before and after placing the thermal insulation somewhere between 3,3 °C and 3.4 °C.
